RE: Assessment of Trees; Western verge of Railway Street, opposite North Cottesloe Primary School

*Assessment of Trees; Western verge of Railway Street opposite North
Cottesloe Primary School*

Town of Cottesloe

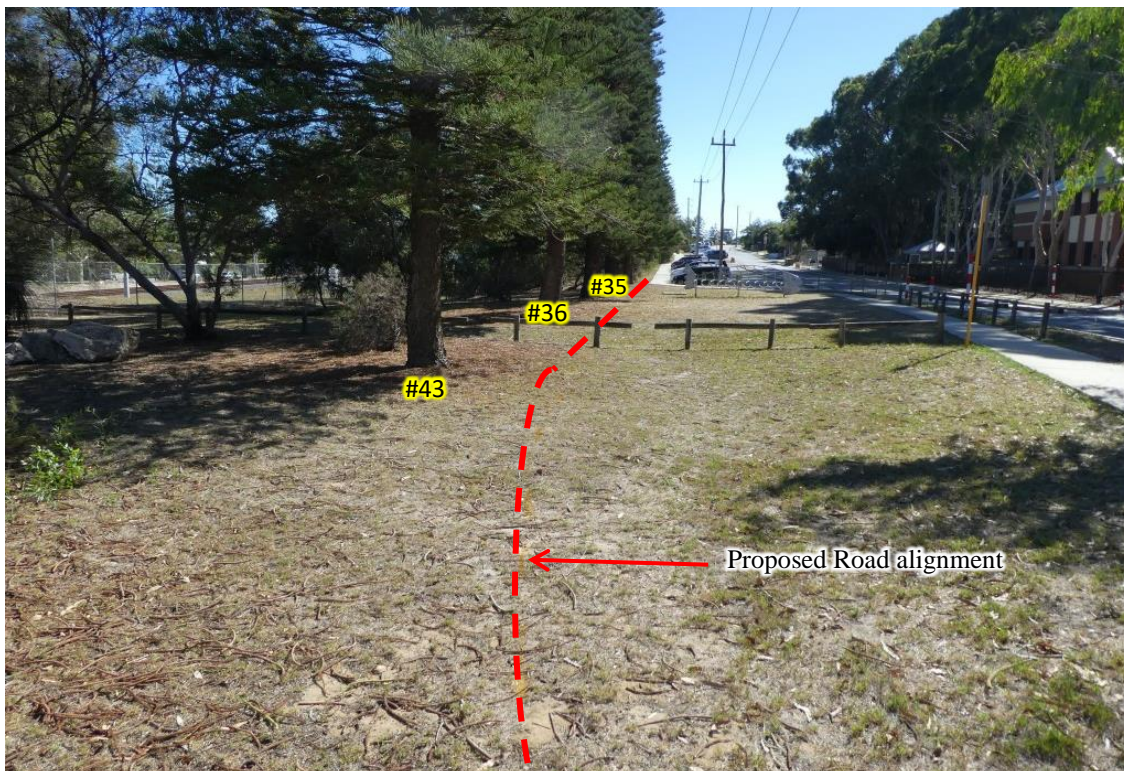
Trees #1, #7, #23 and #24 may have already been subject to some degree of root zone disturbance and possibly loss of root mass when the current existing car parking area was installed, so impact to these Trees may actually be less than to the others.

- 6.1.3 Full impact to these Trees will however be very much dependent on the level of root mass required to be removed to accommodate the depth of excavation required as part of construction.
- 6.1.4 **Recommendations**

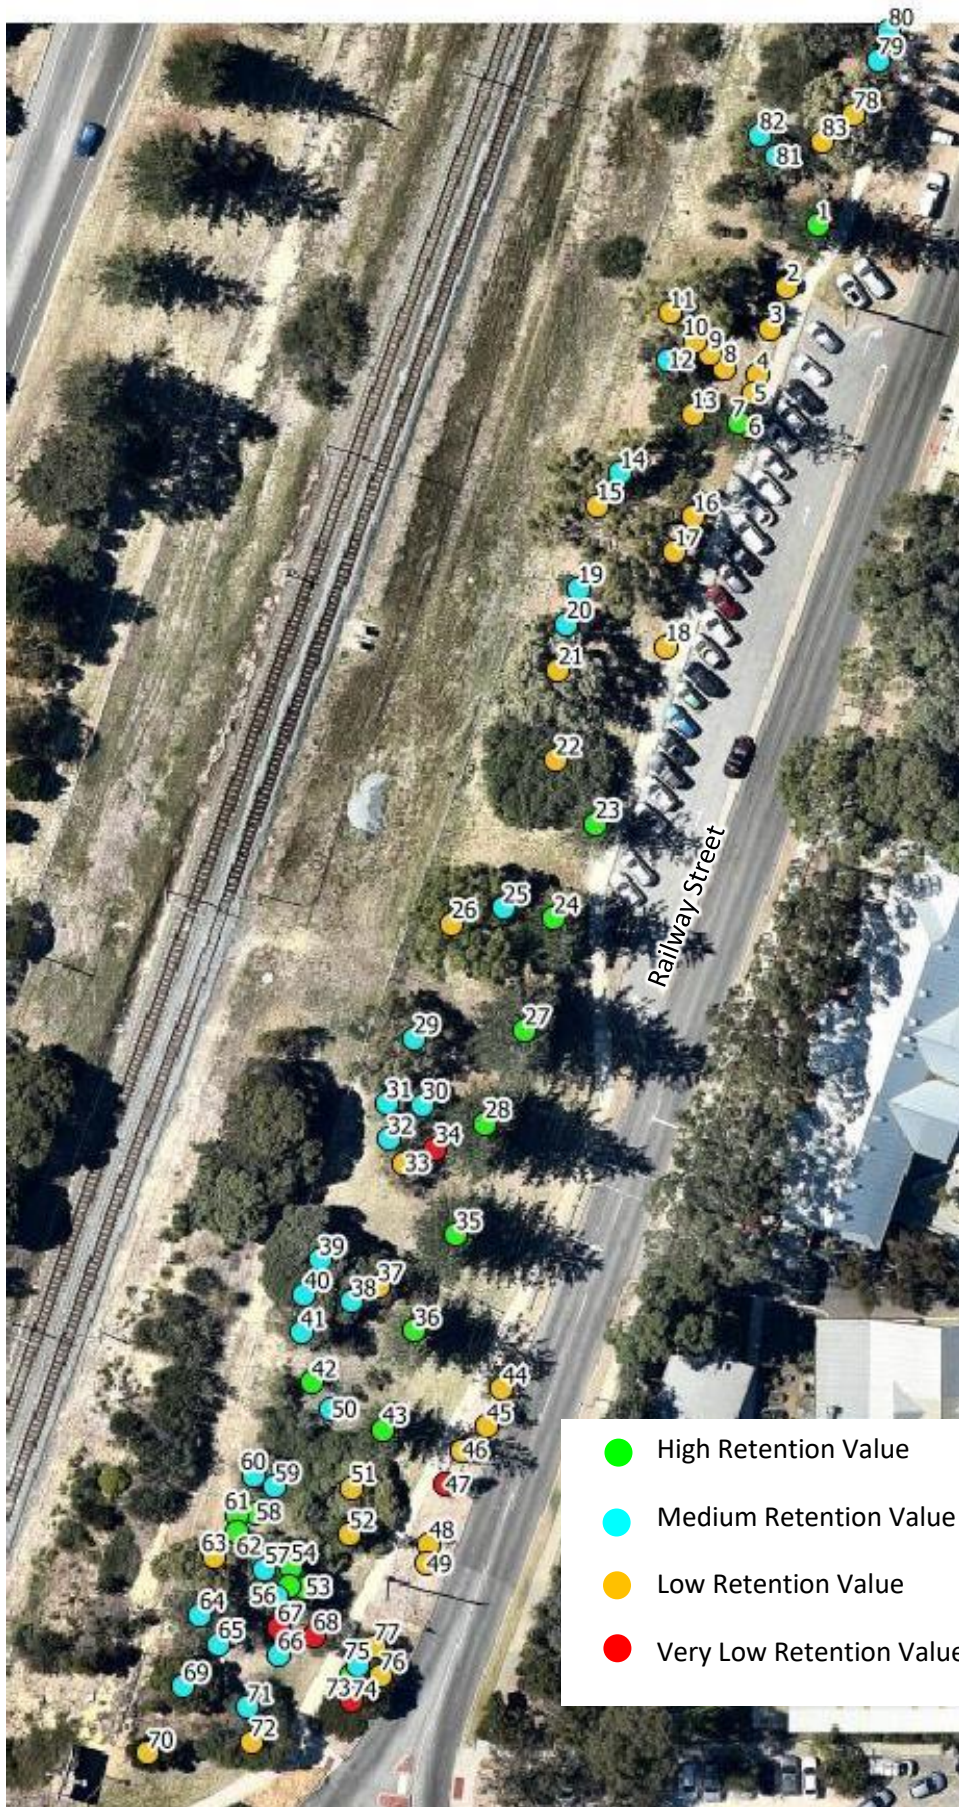
Attachment 2; Tree Location Guide with Retention Value Overlaid

- **33 Trees are considered to have a ‘Low’ retention value** in the context of a development process. Of these Trees
 - 15 of these look to be juvenile trees that would be readily replaceable with limited loss of canopy cover,

- **Five Trees are considered to have a ‘Very Low’ retention value** and would be recommended to be removed as part of any development process of the Site. Of these Trees:
 - 1 looks to be mostly dead,
 - 2 look to have limited life span remaining, and
 - 2 look to be regrowth from the stumps of previously removed trees

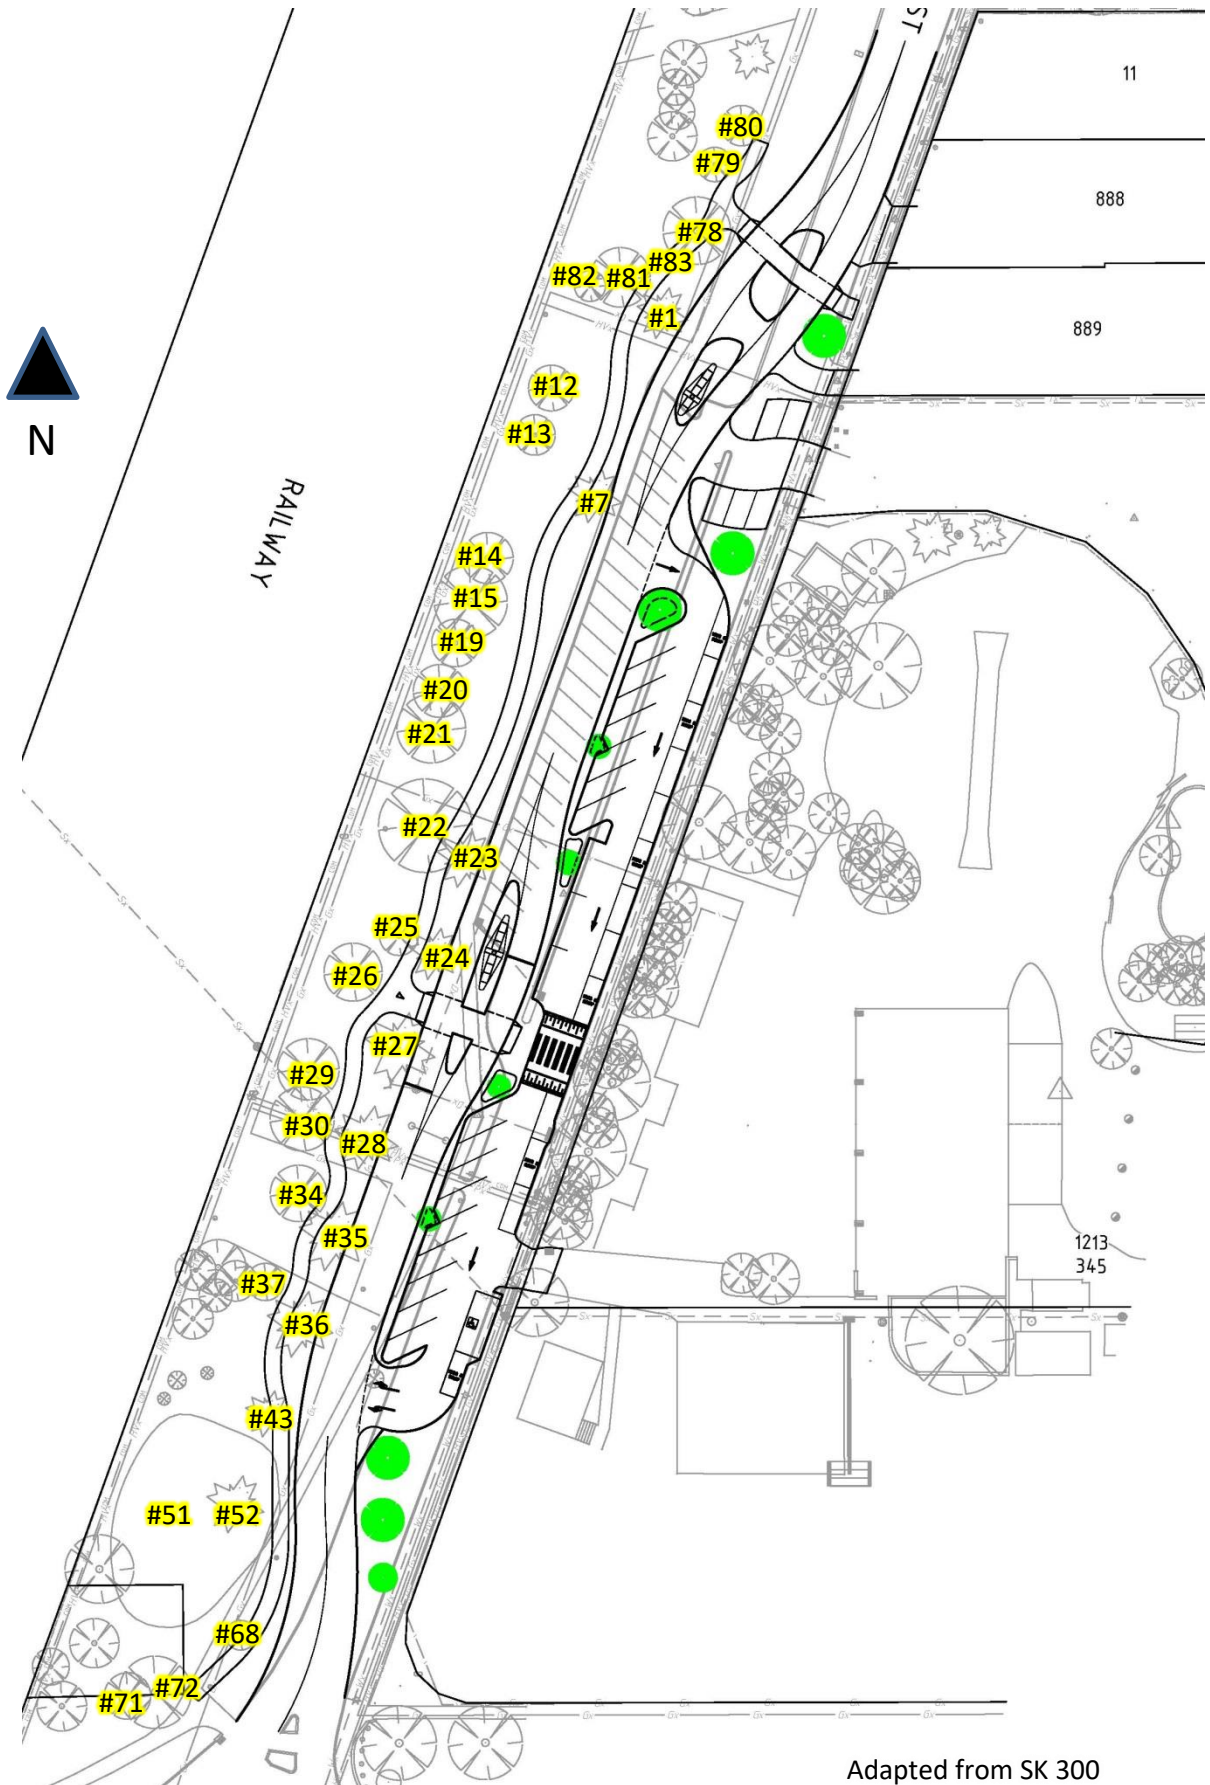
Attachment 3; Location Guide (not all Trees) Overlaid onto Copy of the Plan Provided

- 6.1.1 Based on the Plan provided Trees #44,-#48, and #73 - #77 will need to be removed to accommodate the proposed design. All of these Trees are small and look to only have been planted a few years ago. Two of these Trees are Grass Tree and could be transplanted if required as part of Site clearing works.
- 6.1.2 Potentially significant impact from the construction of the Road looks likely to occur to Trees #1, #7, #23, #24, #27, #28, #35, #36, and #43; particularly Trees #27, #28, #35, #36, and #43 given the proximity of the proposed road pavement and level of excavation anticipated to be required.
