# Cottesloe Coastal Monitoring Summary Report – Summer 2014/2015

**Town of Cottesloe**

**BMT Oceanica Pty Ltd**

*Report No. 1160\_001/1\_Rev0*

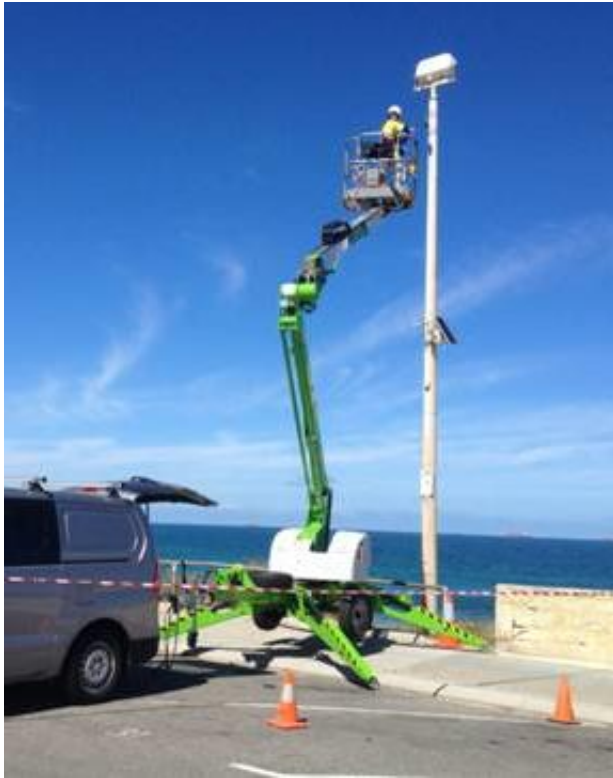
Each remote imagery unit was installed in a locked box and was equipped with long-life batteries and a polarising filter to reduce sun glare and enhance through-water visibility.

**Figure 3.1 Remote imagery unit installation on the light pole in the main beach car park, opposite Overton Gardens**

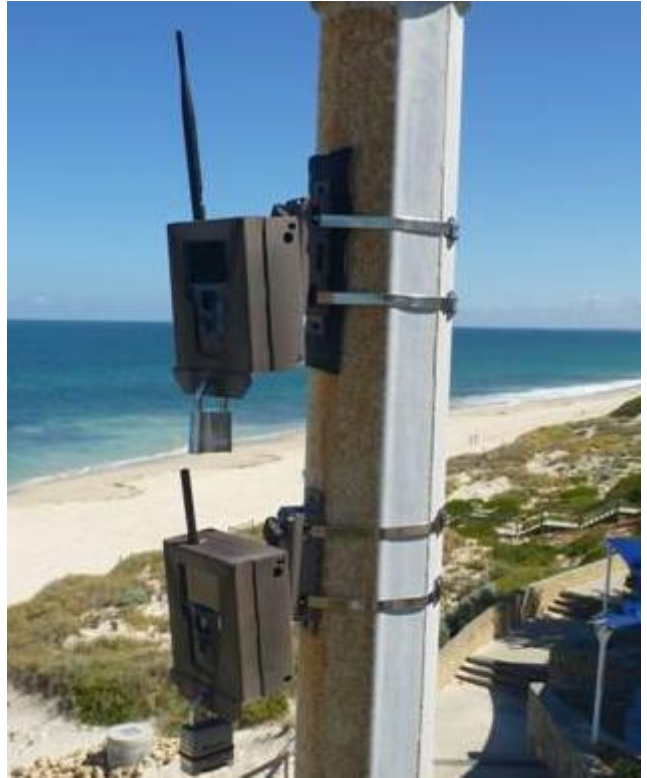
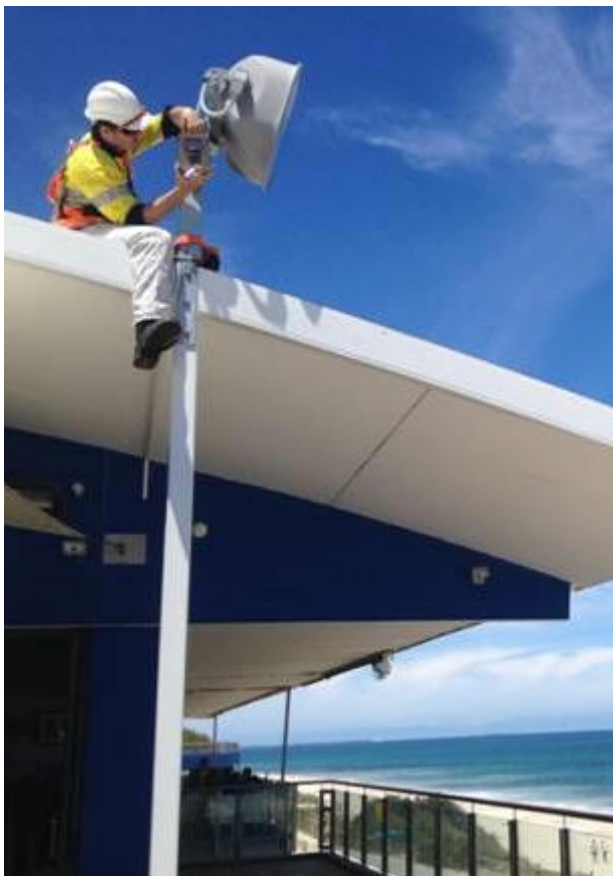
**Figure 3.2 Remote imagery unit installation on the light pole on the North Cottesloe Surf Life Saving Club roof**

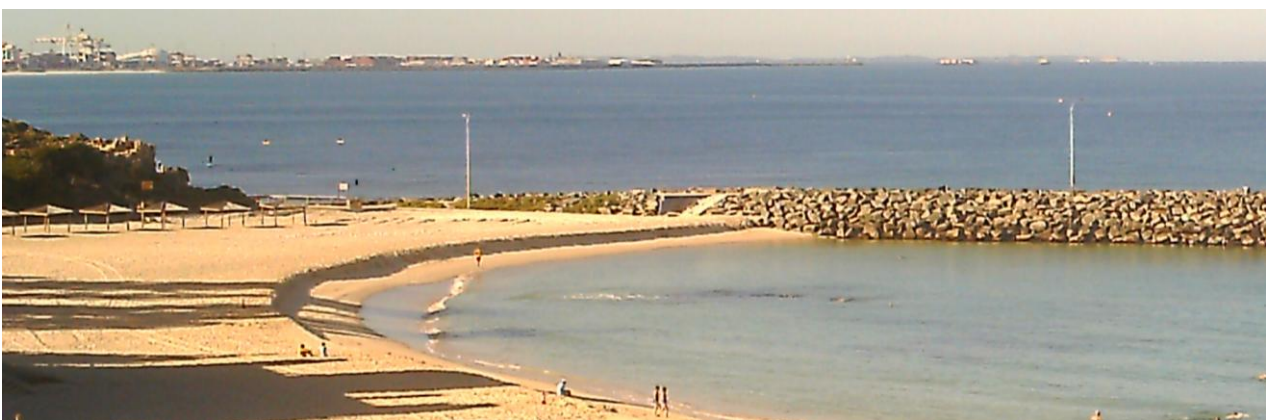
On several occasions throughout the monitoring period, high-resolution imagery of Cottesloe Main Beach indicated the development of 'scarping' in the beach sediment—the formation of low-lying, near-vertical slopes near to the shoreline through accelerated cross-shore erosion during high energy metocean conditions. This was particularly visible in imagery from December (Figure 4.4), and was also evident in a news article photo regarding beach erosion at Cottesloe in mid-March (Appendix B).

**Figure 4.4 Close-up of the southern end of Cottesloe Main Beach on 6 December 2014**

- Reduction in beach width reduces beach amenity and restricts the space available for beach-goers at this popular location.
- Scarping of beach sediment and exposure of rock near the shoreline (as observed in remote imagery; Section 4.1.3) may pose a safety hazard to beach-goers and swimmers.
- Periods of accelerated erosion may affect the 'Sculptures by the Sea' exhibit in future summers, as occurred in mid-March 2015 when some sculptures had to be moved further from the shoreline to avoid being damaged due to beach erosion (see news article in Appendix B).
- Loss of the beach fronting the Indiana Restaurant may lead to storm waves breaking onto the building, risking damage to the structure.
